PRELIMINARY (35%) REMEDIAL DESIGN REPORT

OPERABLE UNIT 1 – PHASE 1 REMEDIAL ACTION
MARTIN AARON SUPERFUND SITE
CAMDEN, NEW JERSEY

Submitted By: Golder Associates Inc.
200 Century Parkway, Suite C
Mt. Laurel, NJ 08054 USA

September 2013

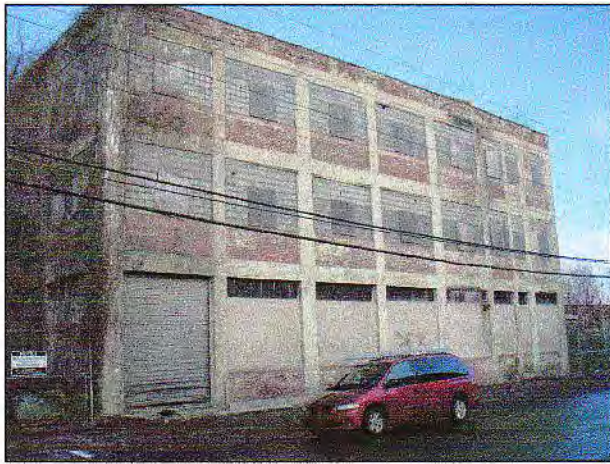
Photograph 1: East Wall, Ponte 3

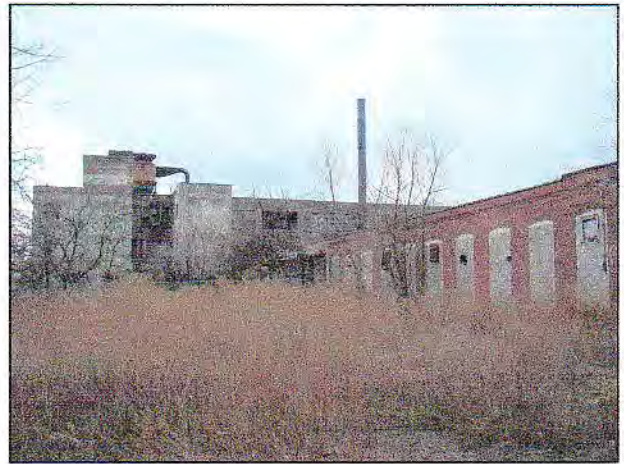
Photograph 2: North wall, Ponte 3, with Ponte 1 on the right. Note steel stack

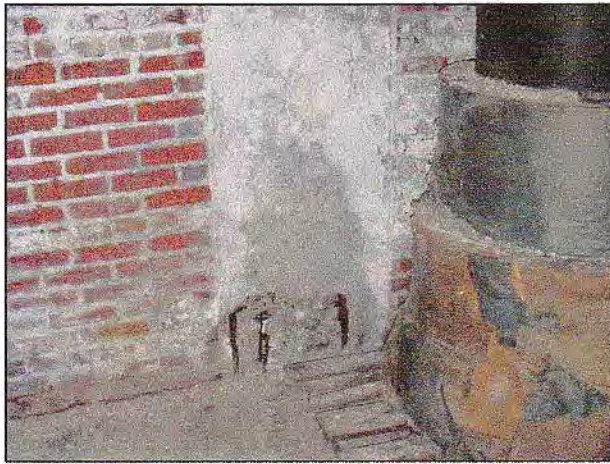
Photograph 7: Concrete spall at base of column

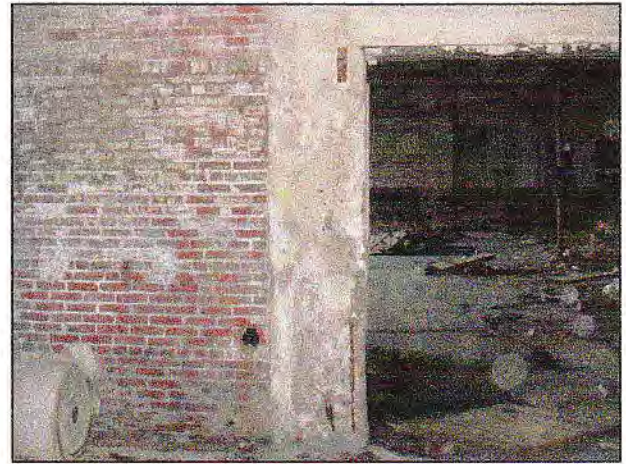
Photograph 8: Concrete spalls and forklift damage at column

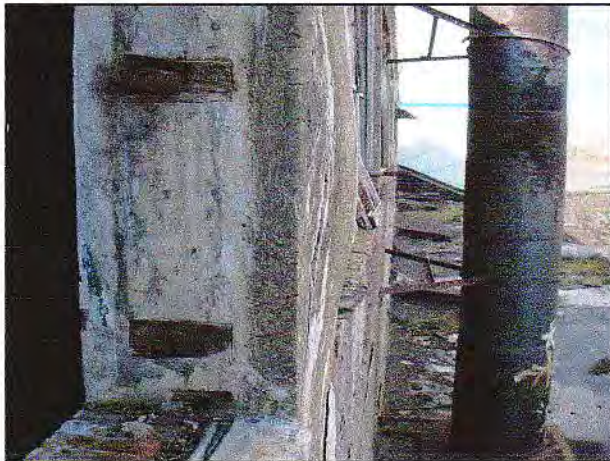
Photograph 9: Column bulge, third floor

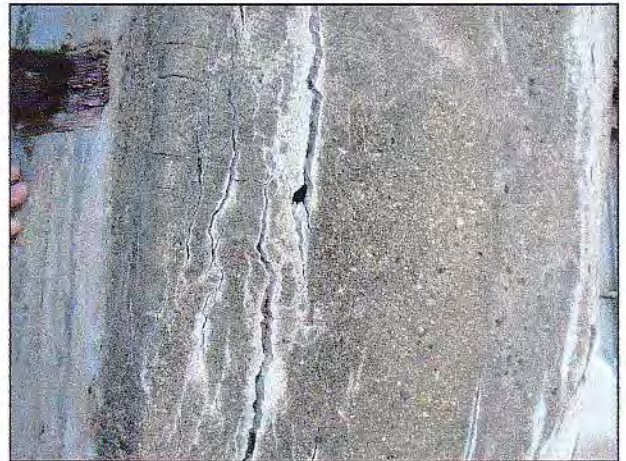
Photograph 10: Close-up of cracking at column bulge

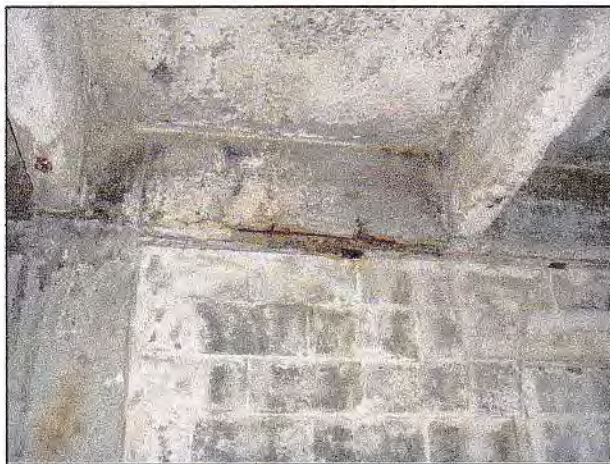
Photograph 11: Girder damage – concrete spalling over bottom rebar and on web

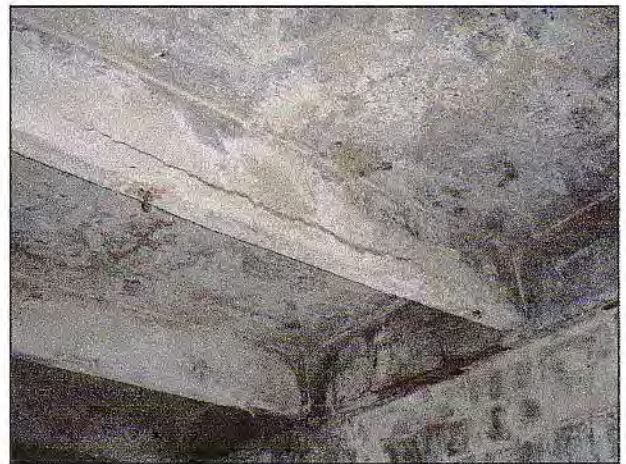
Photograph 12: Concrete joist damage – large spall below bottom reinforcing

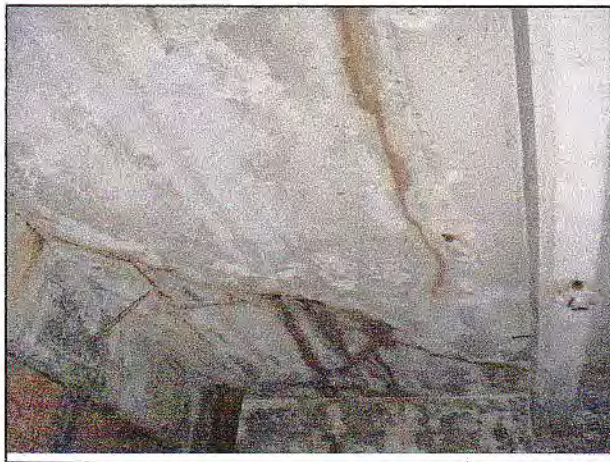
Photograph 13: Roof slab cracking, northwest corner

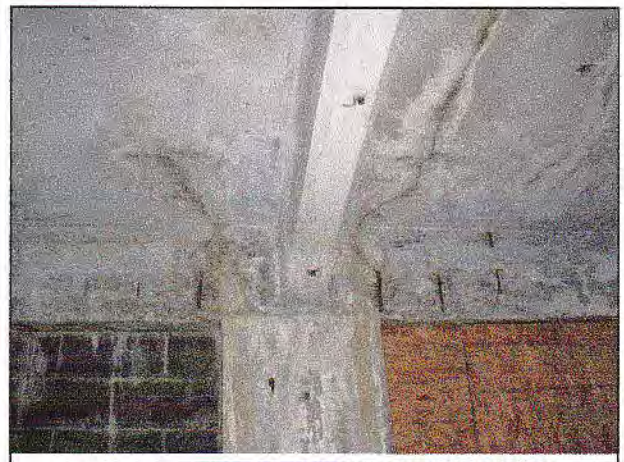
Photograph 14: Roof girder and roof slab damage

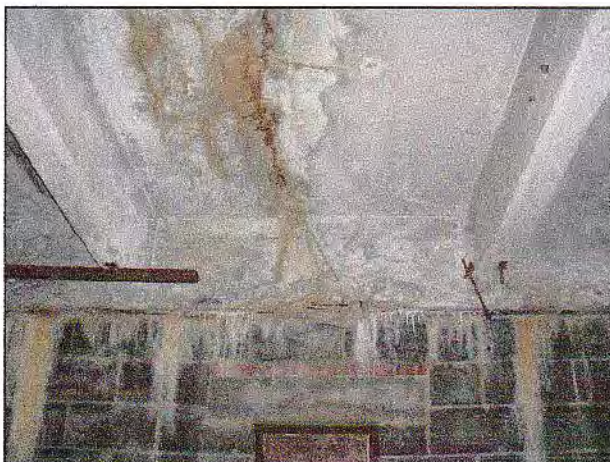
Photograph 15: Roof girder and roof slab damage

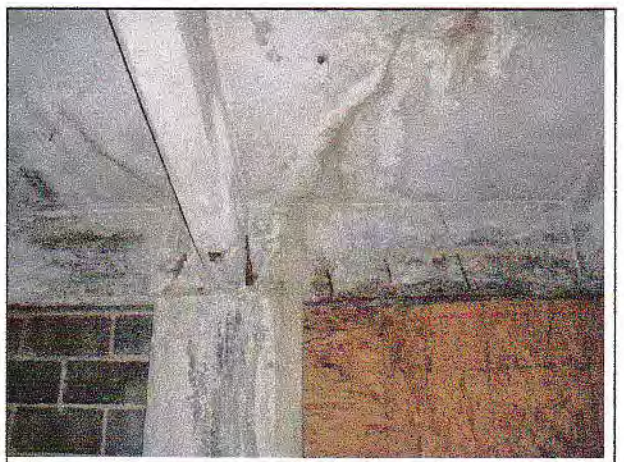
Photograph 16: Roof girder and slab damage

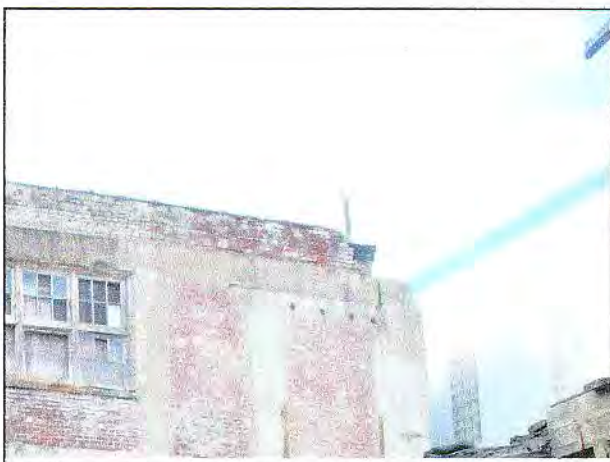
Photograph 17: Parapet damage, northwest corner

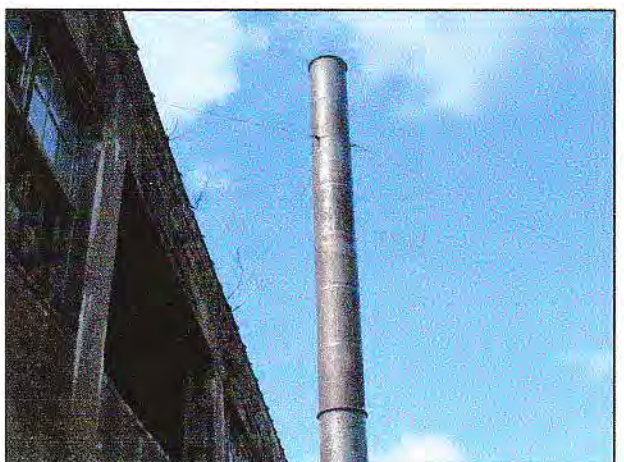
Photograph 18: Steel Stack. Guy wire to the right must be removed during demolition.

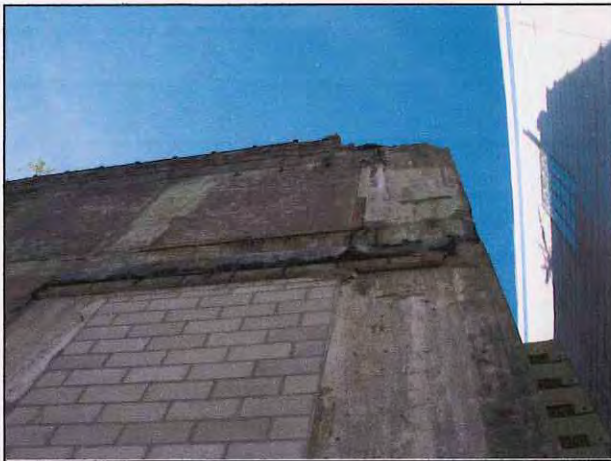
Photograph 3: North wall parapet, northwest corner

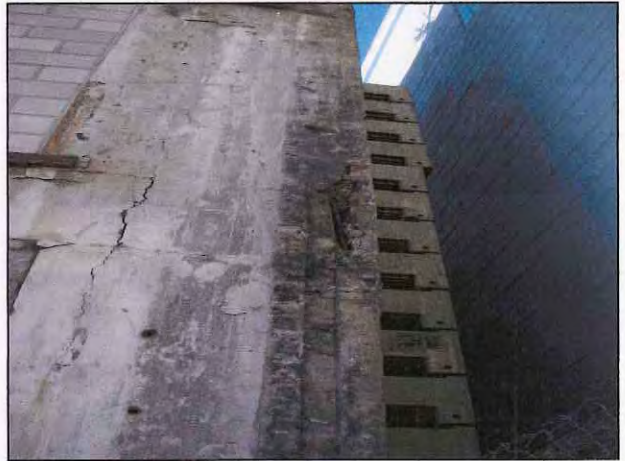
Photograph 4: Brick crack, Ponte 1 northwest corner

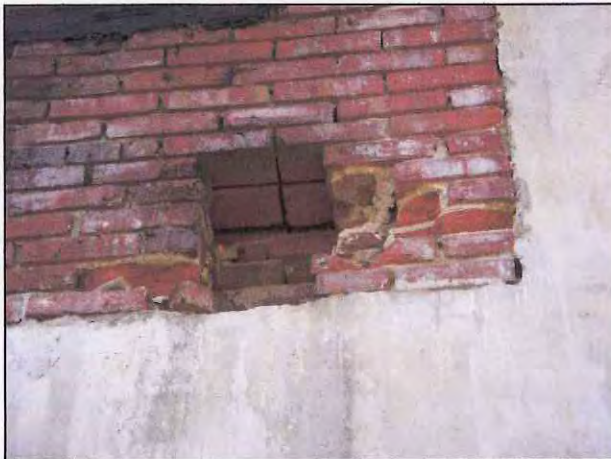
Photograph 5: Brick damage at beam pocket (worst case)

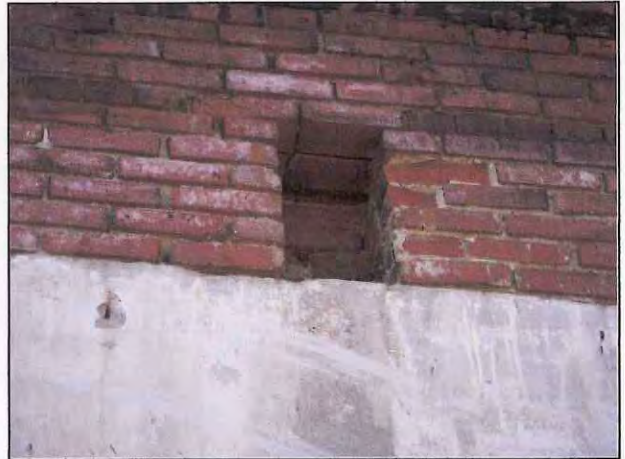
Photograph 6: Brick damage at beam pocket (typical condition, where present)

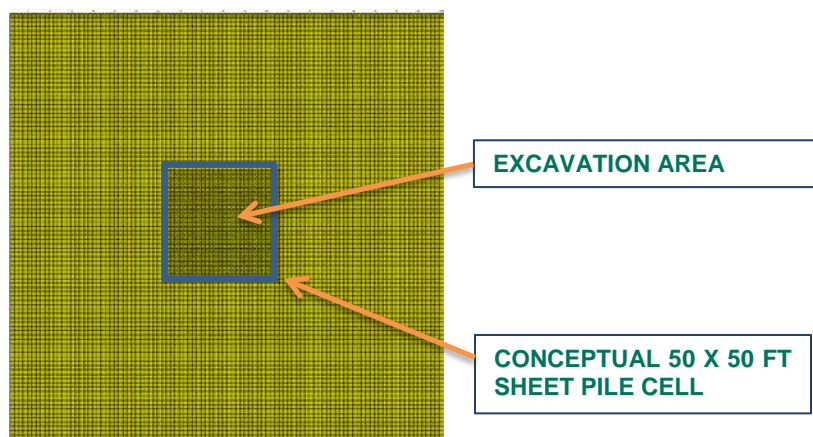
Figure 1: Model Domain

excavation area is bounded by sheet piles on 4 sides, which were terminated at a depth of 24 feet below ground surface in a semi-confining layer found discontinuously in the Cape May Formation beneath the Site. Figure 1 shows the model domain. The model has six layers representing the Site hydrostratigraphy as depicted in Figure 2 and representative of prior investigation findings.

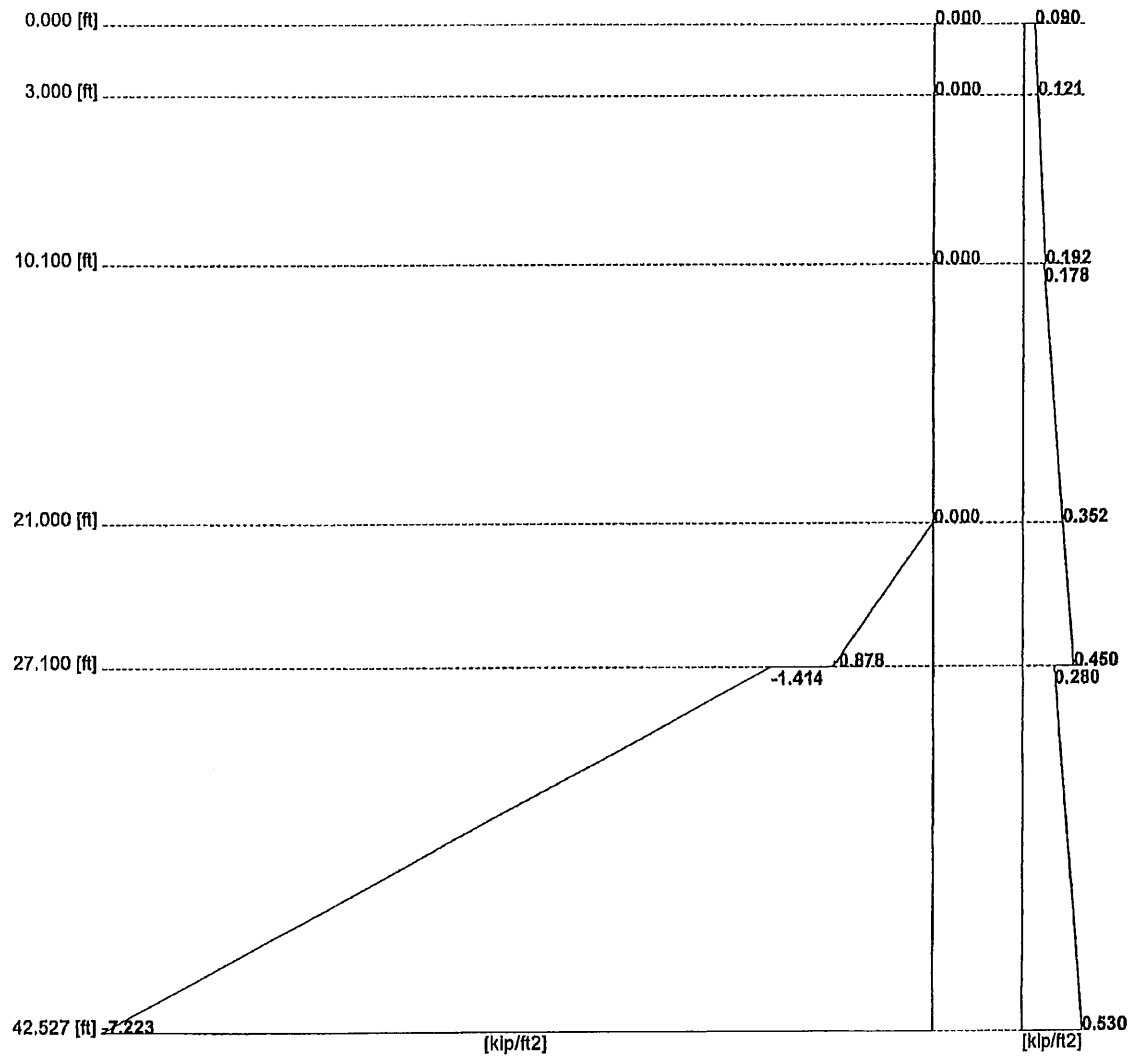
Fig 11/18

Earth Pressure Diagram

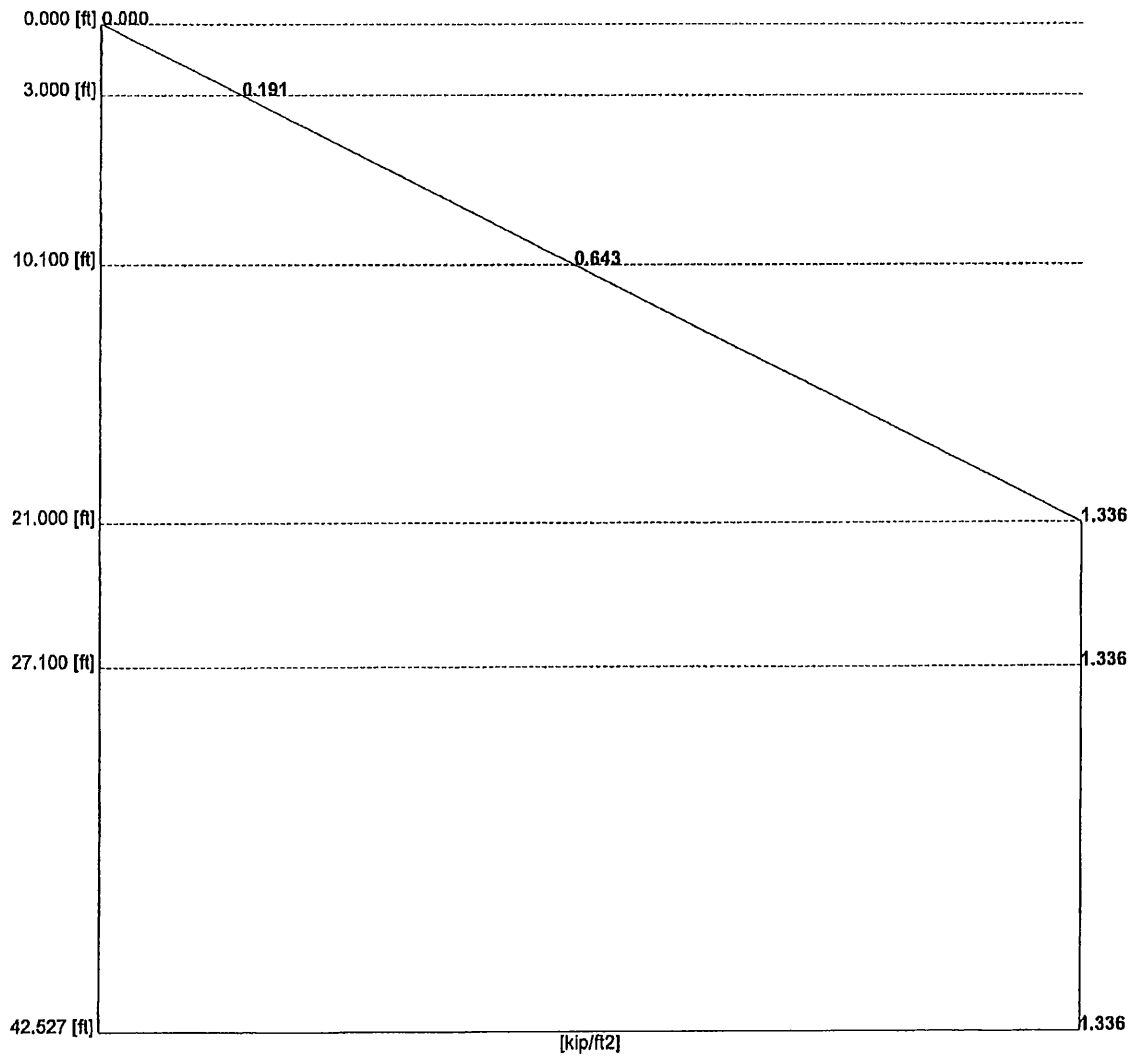
Fig 12/18

Water Pressure Diagram

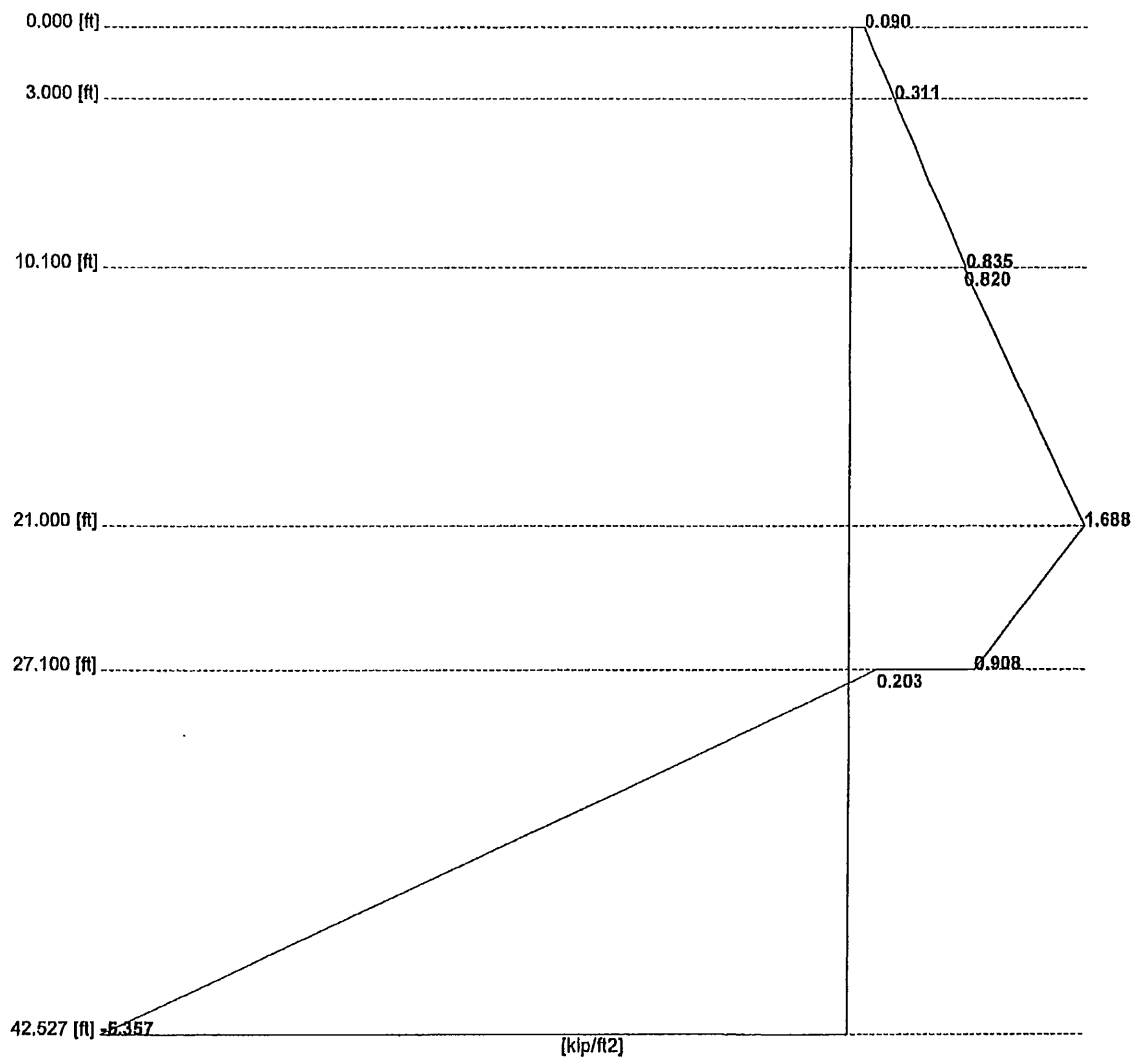
PG 13/18

Total Pressure Diagram

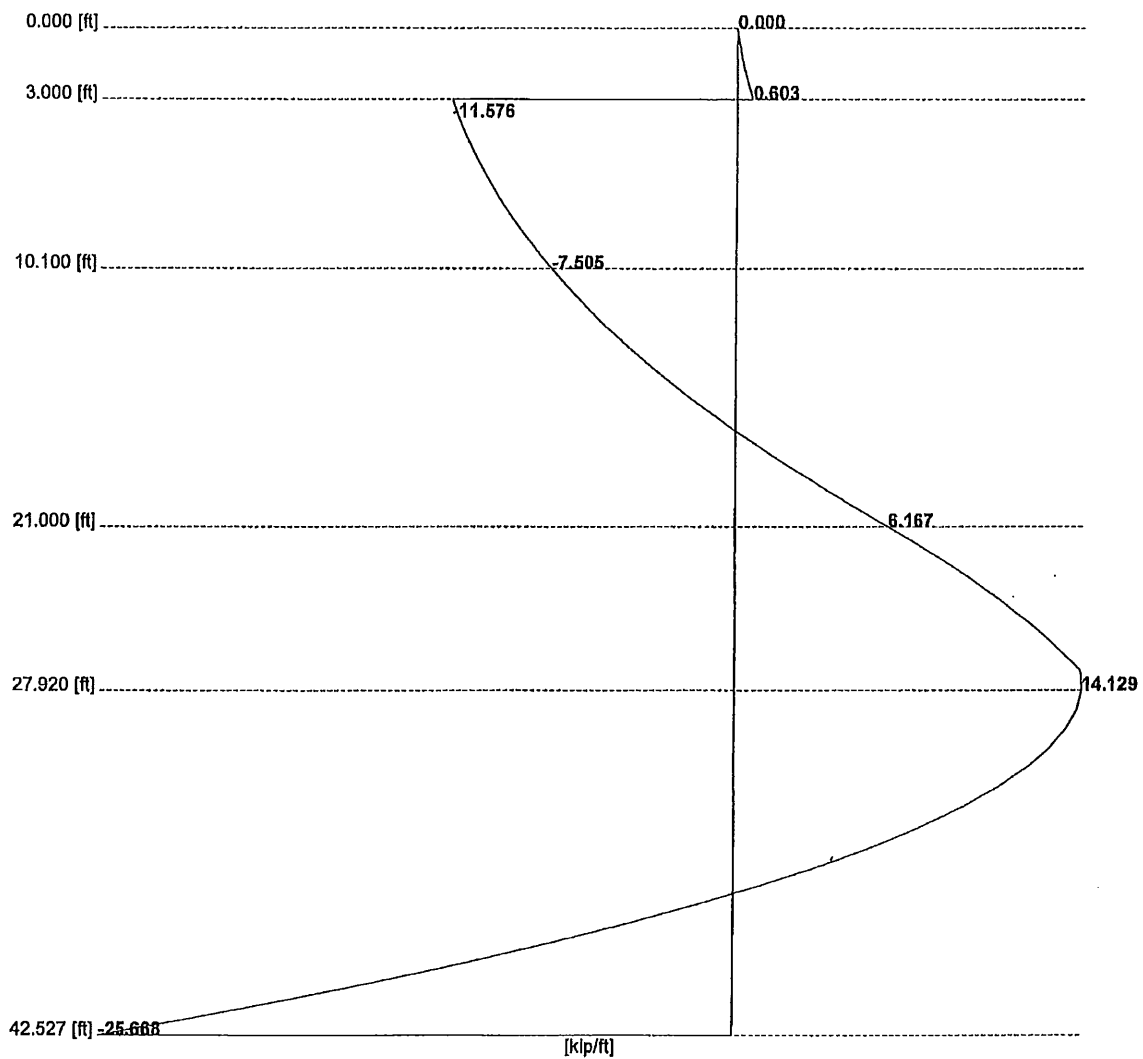
Pg 14/18

Cross Force Diagram

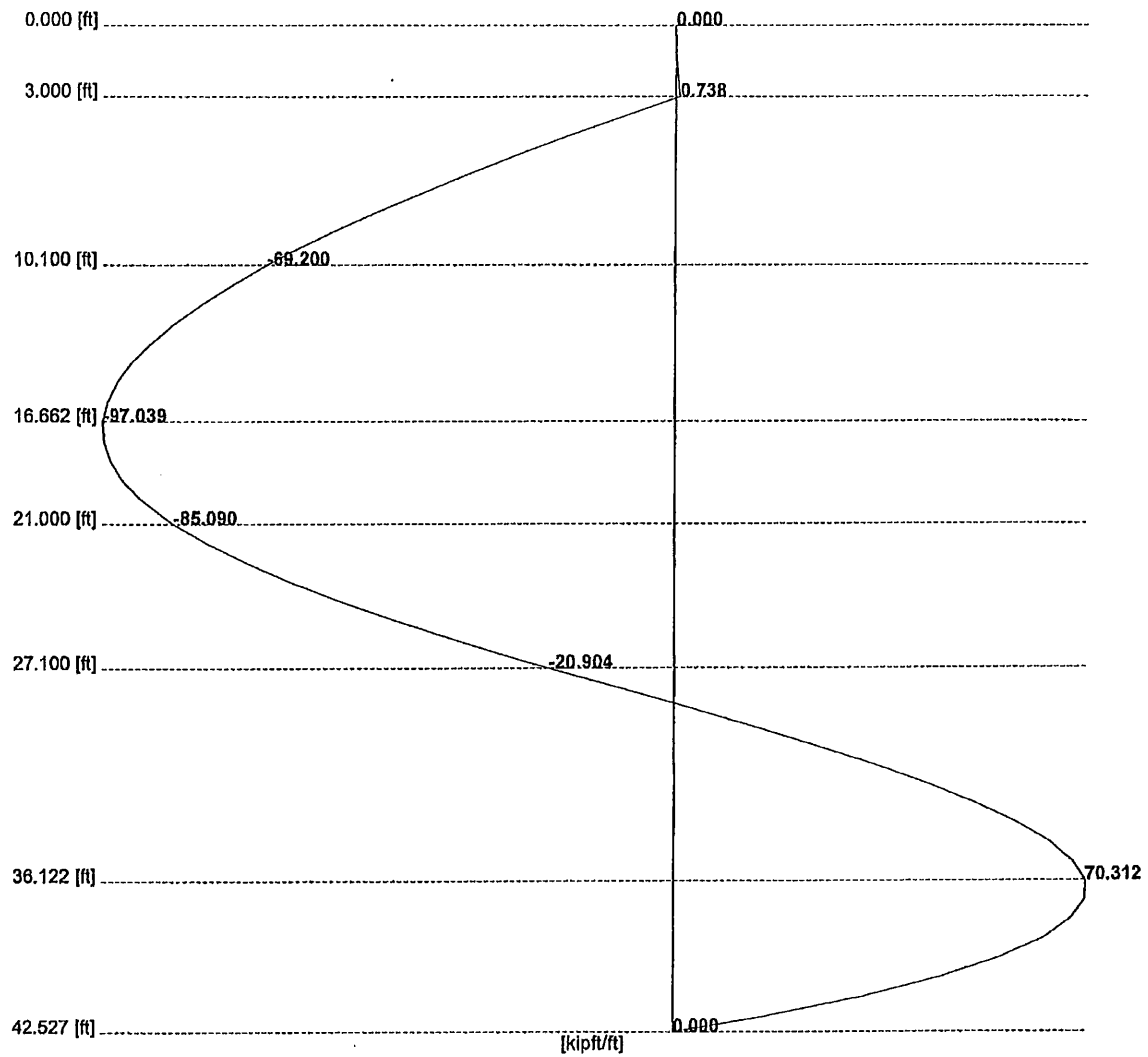
Pg 15/18

Moment Diagram

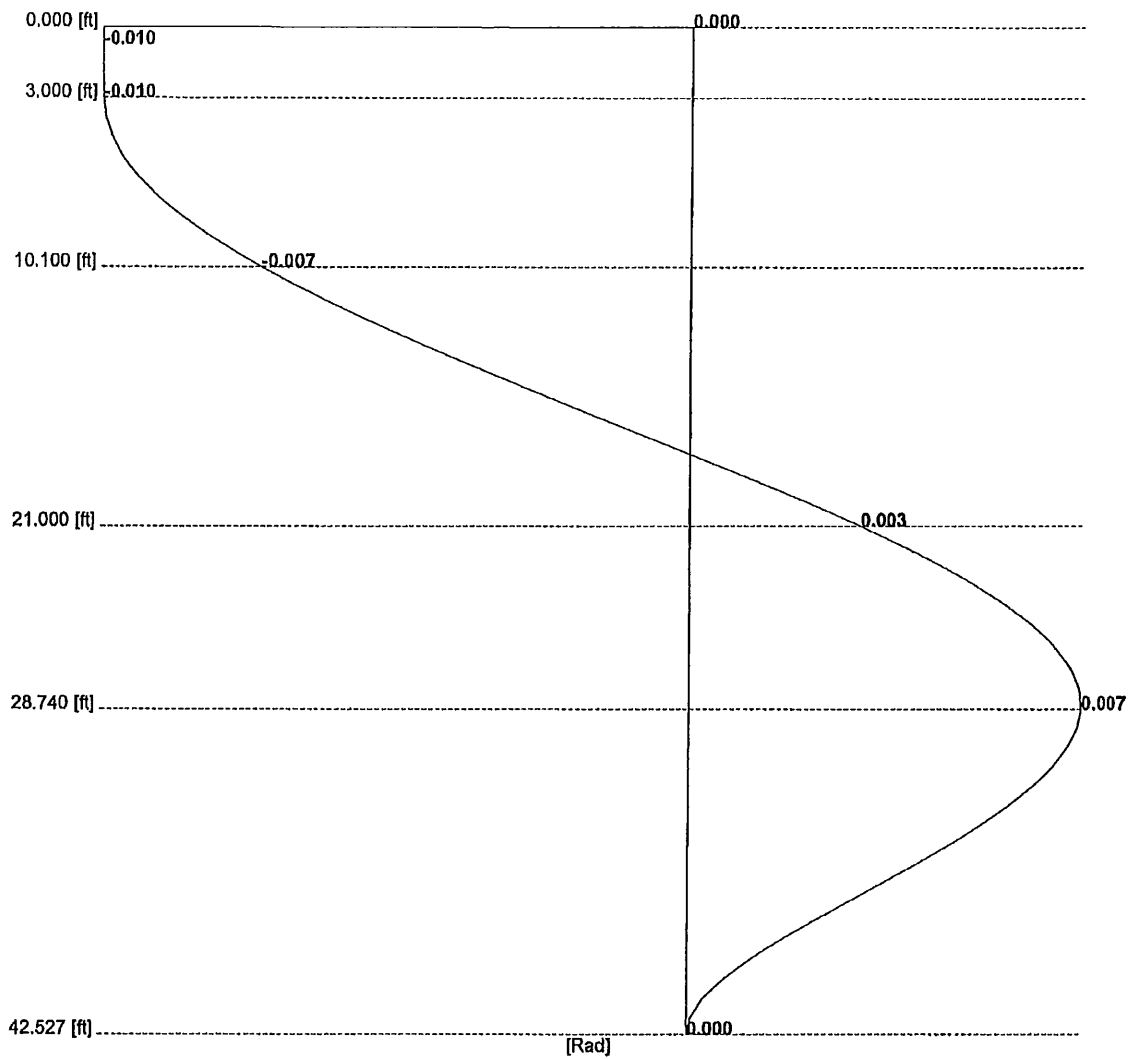
Pg 16/18

Rotation Diagram

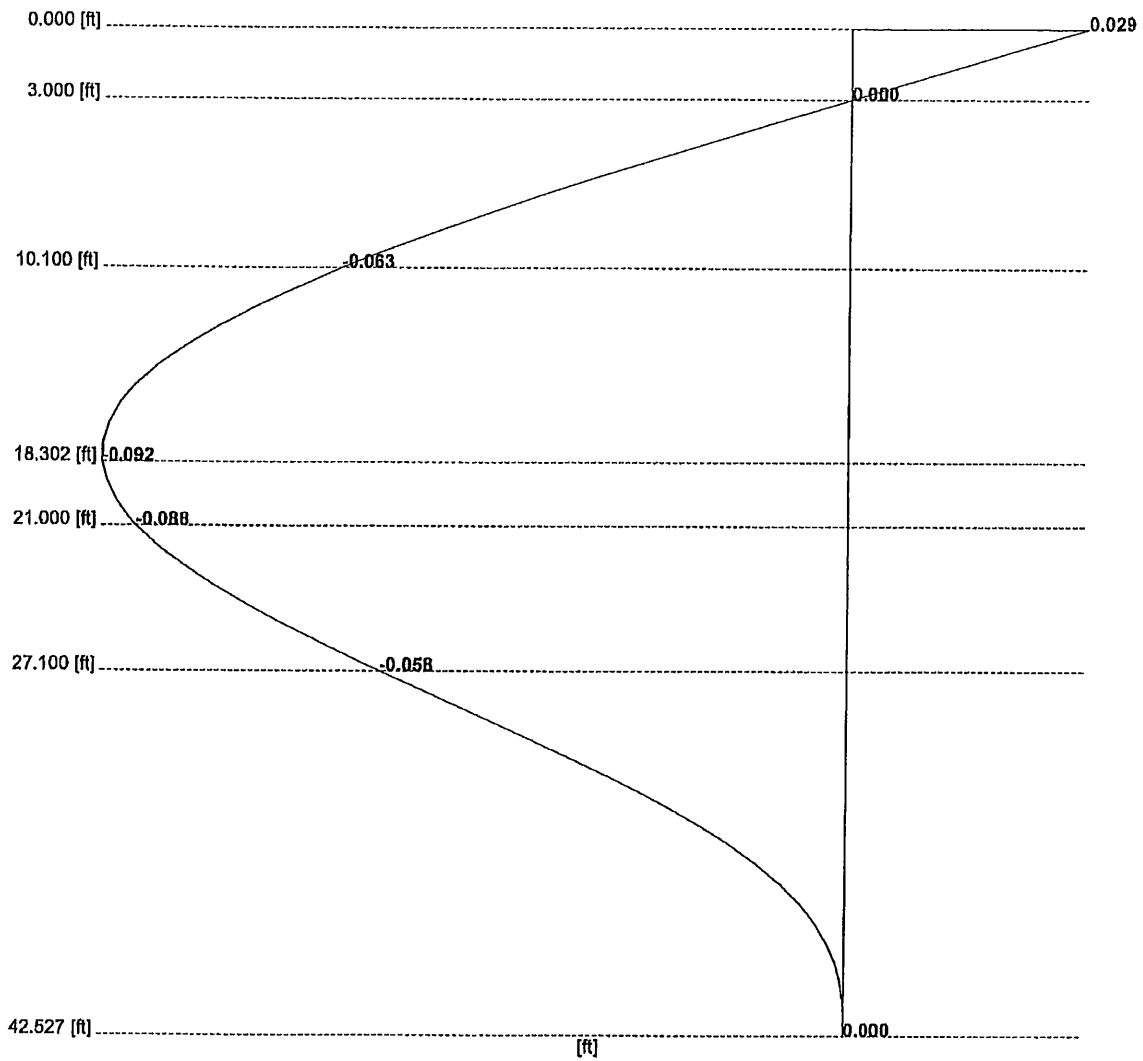
Pg 17/18

Deflection Diagram

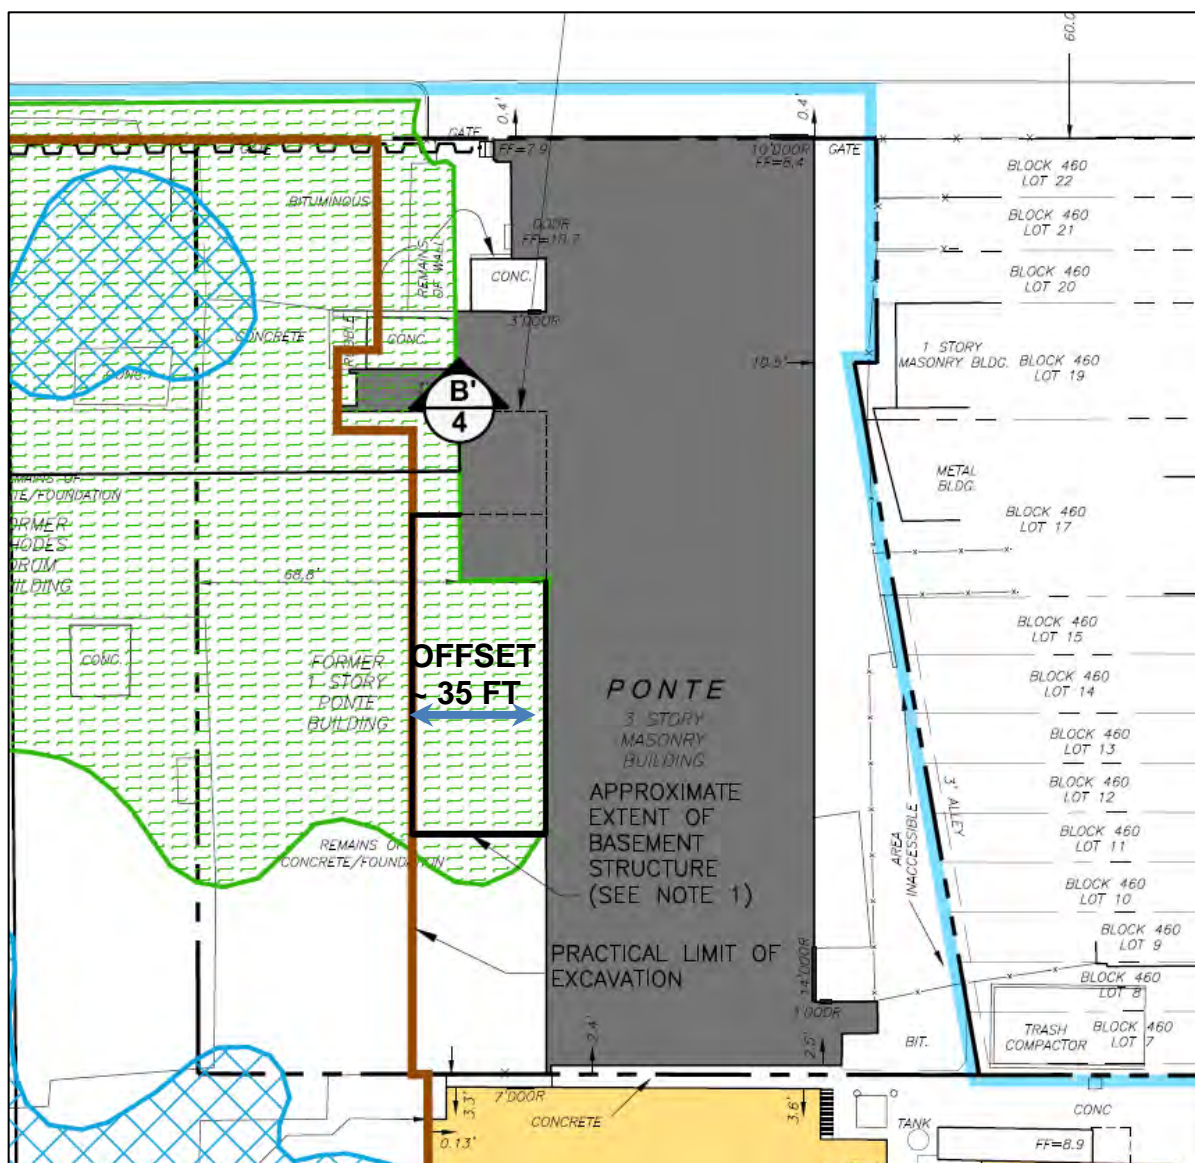
Figure 1: Offset to Practical Limit of Excavation from Ponte Equities Building

In order to not adversely affect the existing structural condition of the three-story Ponte Equities Building, which includes the one-story boiler house, the preliminary design of the practical limit of excavation is at an offset from the north façade of the three-story structure. This practical excavation boundary is coincident with the north wall of the buried basement and existing longitudinal joint of the former one-story building floor slab. This offset will avoid removing the existing support of the boiler house, which partially straddles the buried basement. The offset provides separation which allows for attenuation of construction-induced vibrations between the remedial excavation face and the three-story building façade and also allows the installation of sheeting to decrease the influence of dewatering activities on the building.

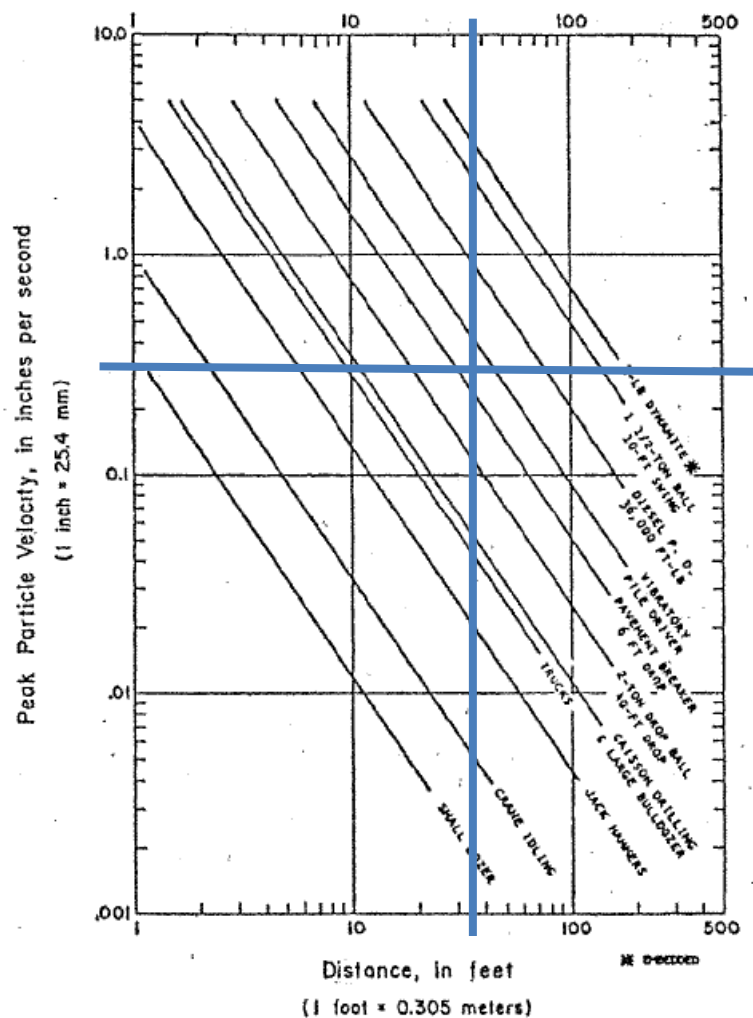
Figure 2: Relative Intensities of Construction Vibrations (Reference 2)
